Characteristic properties of the microstructure and microtexture of medium-carbon steel subjected to sulfide stress cracking

This work is aimed to identify the structure-phase features and regularities of the texture formation processes, in a standard production string coupling made of bainitic steel structure, as well as to establish the factors determining its resistance to hydrogen sulfide stress cracking.

A production string (PS) coupling with an outer diameter of 139.7 mm and a wall thickness of 9.17 mm, manufactured according to the GOST 31446 standard (strength group P110), was selected as the research material. The chemical composition of the investigated coupling is shown in Table 1.

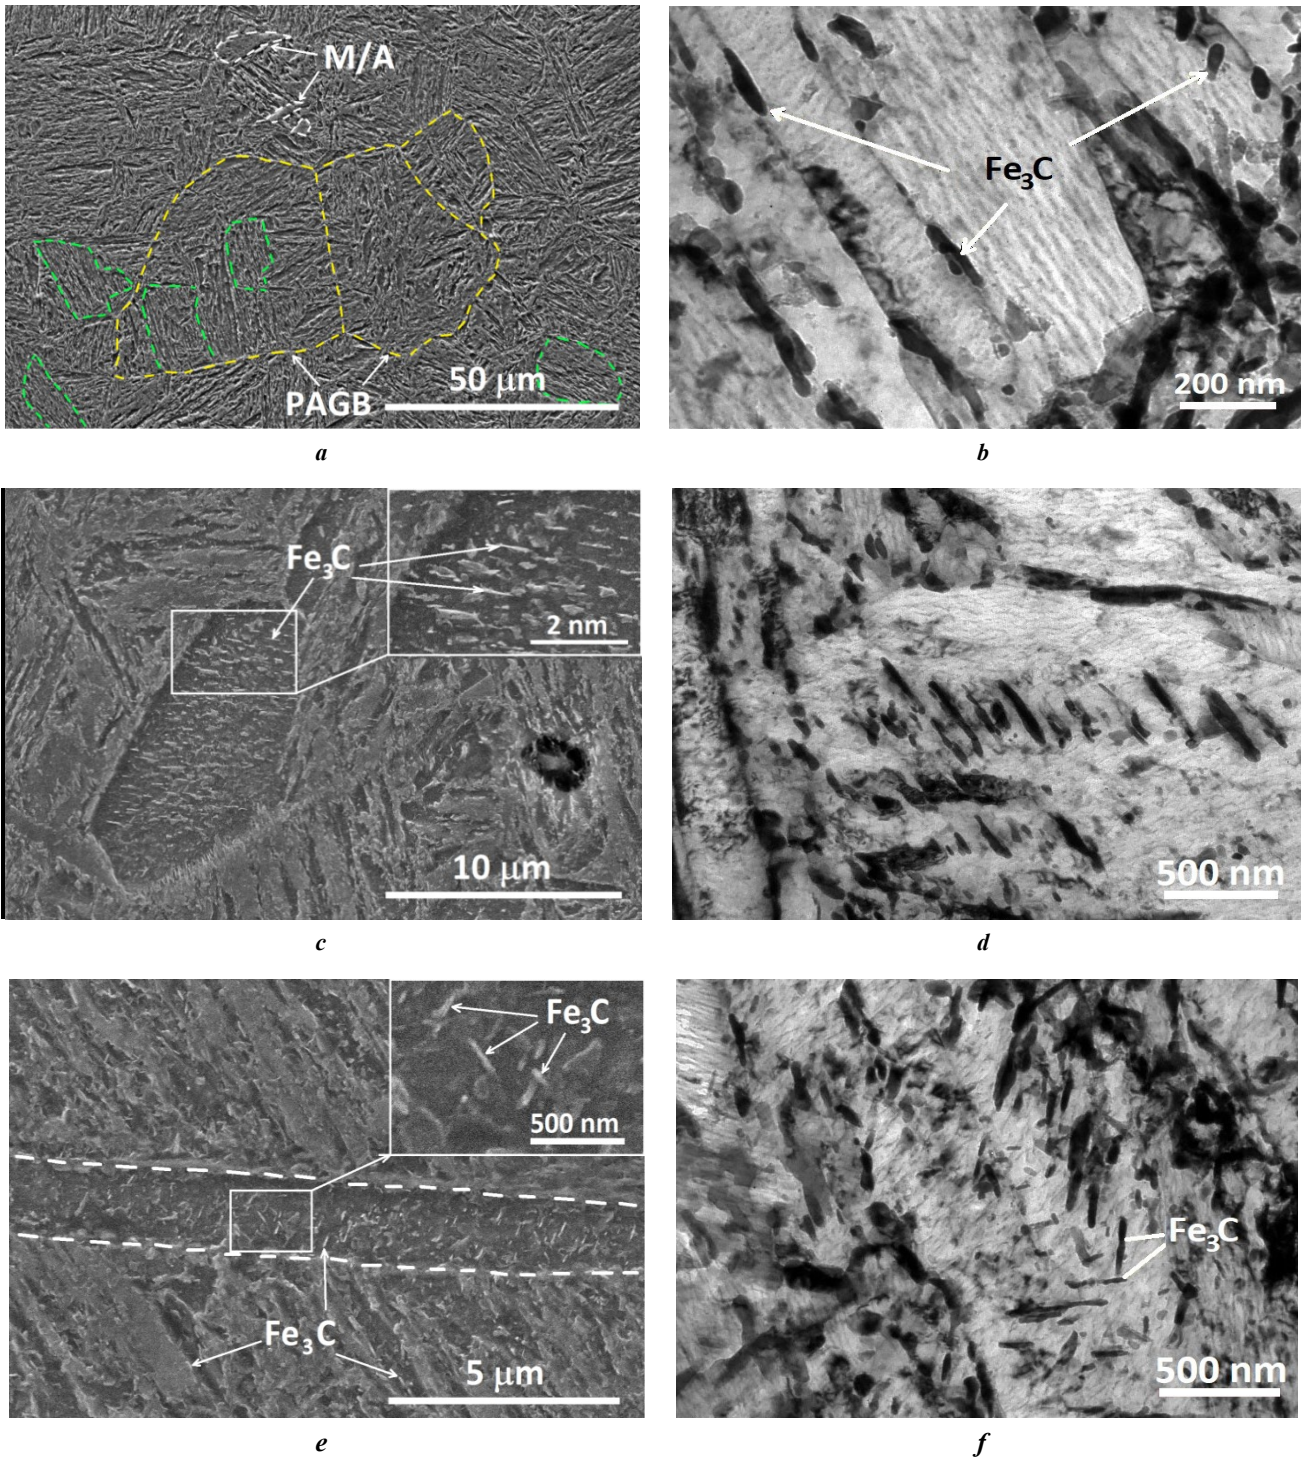
Fig. 1 a shows a typical SEM image of the PS coupling microstructure (before operation) after etching. The experimental microstructure is mainly characterized by a bainitic structure consisting of parallel plates. In the photograph, the bainite plates are shown as disoriented blocks inside the PAGB (Fig. 1 a). The bainitic blocks in Fig. 1 a in some places are circled by green contour lines, and PAGB – by yellow lines. Along with the bainite component, the microstructure contains the irregularly shaped islands of the martensitic-austenitic (M/A) phase (Fig. 1 a). Unlike the bainite component, the M/A areas are resistant to etching; they look like non-etched and relatively light areas (outlined with a white line) (Fig. 1 a). A microstructure detailed analysis at rather high magnifications showed that the bainite component is formed from the upper bainite (UB) and lower bainite (LB) plates. This fact is supported by the results of SEM and TEM studies, according to which the needle-like cementite (Fe_3C) particles in the UB plates are located only at the plate boundaries and are oriented along the boundaries (Fig. 1 b) [10]. The detected cementite particles at the boundaries of the UB plates in some places grow up to a length of 170 nm, while their diameter equal to ~34 nm remains practically unchanged. At the same time, in the LB, cementite particles are formed only in the body of the plates (Fig. 1 c, 1 d). In this case, the cementite particles in the LB have a needle-like shape (up to 210 nm long, 22 nm in diameter) and are parallel to each other (Fig. 1 c, 1 d). Fig. 1 d shows the section of the “coalesced” LB, where the merge of parallel plates is observed. In the PS coupling microstructure, rather large plates of tempered martensite (TM) are observed in some places (Fig. 1 e, 1 f). Similar structural components (LB, UB, and TM) in steels were previously observed in the works [17–19]. The TM plates (laths) have a length of up to several tens of microns and a width of 1–4 microns. The difference between the TM and the UB and LB is that, in the TM plates, cementite particles of the needle-like morphology are oriented between themselves both parallel and at an angle of 60° with respect to each other (Fig. 1 e, 1 f) [19].

Fig. 1. Images of the PS coupling microstructure (before operation):

a – microstructure general view; *b* – upper bainite plates;

c, d – lower bainite plates; *e, f* – martensite tempering plates.

The analysis of the microstructure of the medium-carbon steel PS coupling showed that various structure components are formed in it: upper bainite, lower bainite, and tempered martensite (Fig. 1). These structural components differ both by the arrangement of cementite particles and their mutual orientation, and by the dimensions of the plates (laths). In particular, the average width of the UB plates is $0.7 \mu\text{m}$, and the length is $\sim 25 \mu\text{m}$. Cementite particles in the UB plates are located along their boundaries [16–18]. Compared to the UB, the width of the plates in the LB is a bit narrower ($0.5 \mu\text{m}$), and their length does not exceed $20 \mu\text{m}$. Needle-like cementite particles in the LB precipitate in the body of the plates and are strictly parallel to each other [16–18]. In the tempered martensite plates, the cementite particles precipitate in the form of needles located in the body of the plates (laths) and are oriented to each other both in parallel and at an angle of 60° with re-

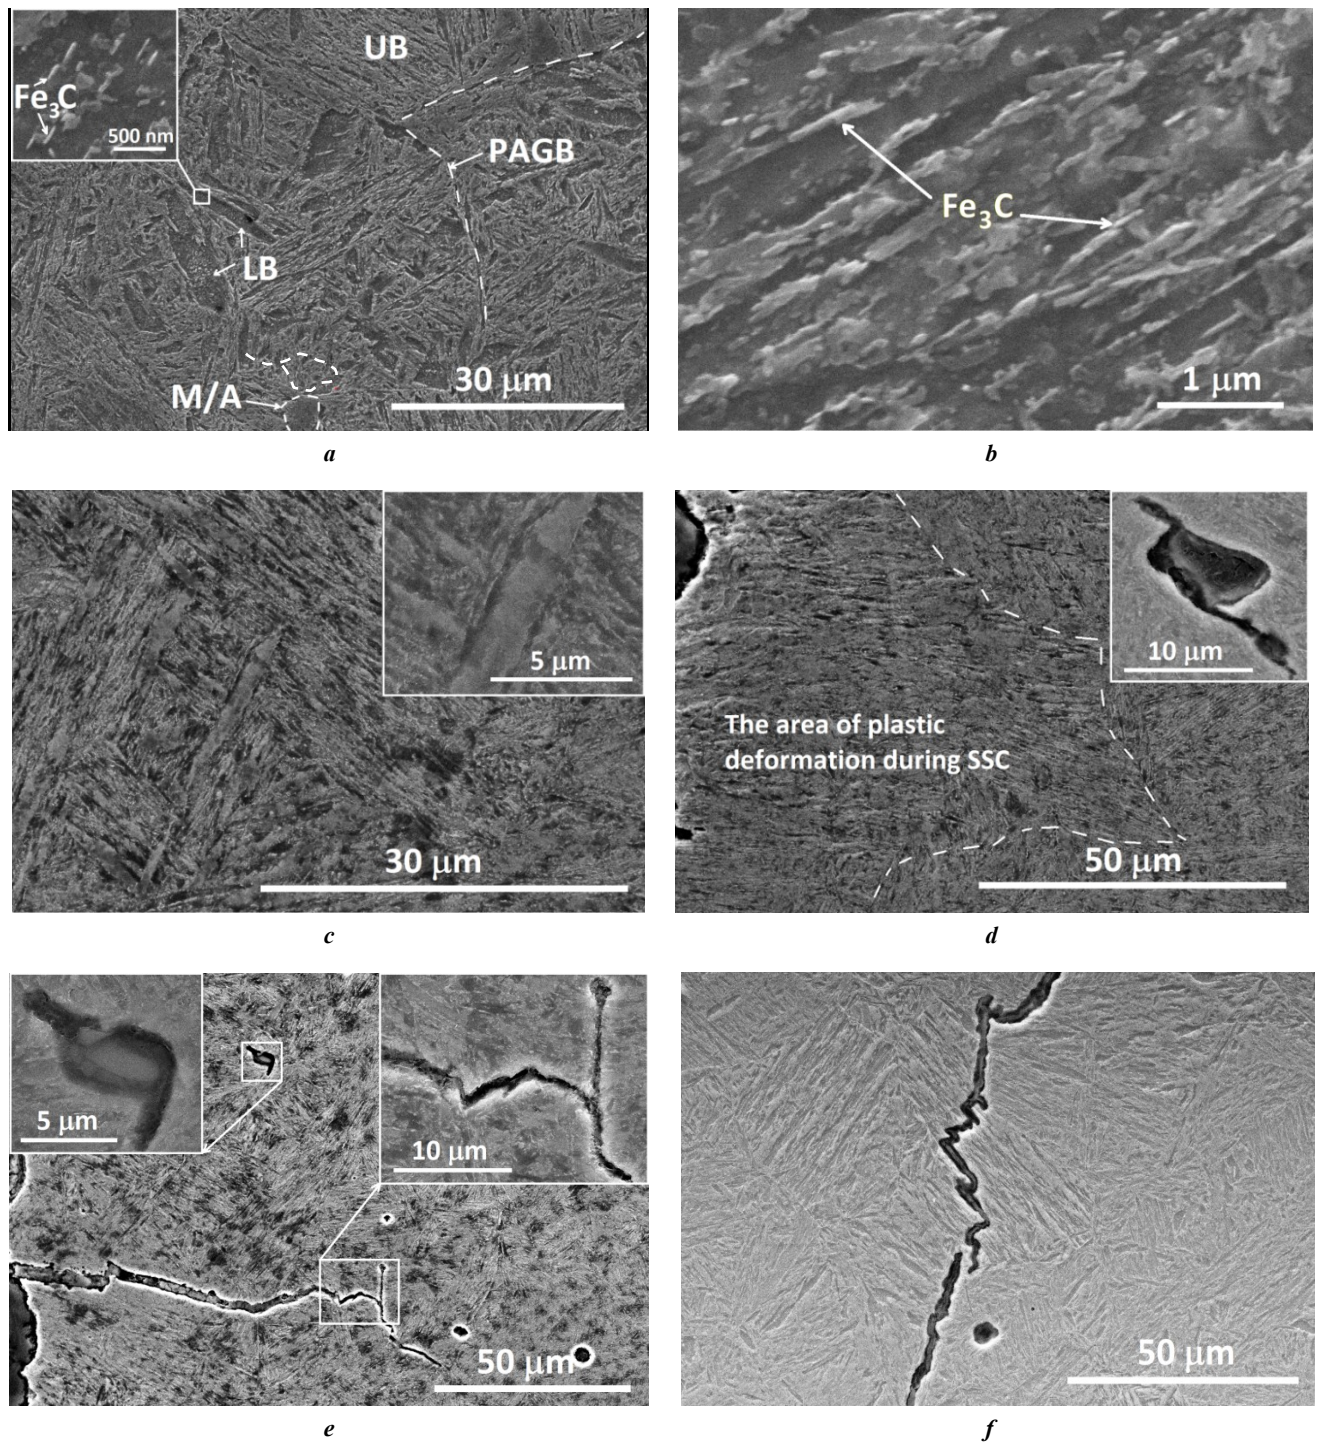
Fig. 2 a shows a typical SEM image of the PS coupling microstructure after operation. The precision SEM analysis showed (Fig. 2 a, 2 b) that the microstructure of the PS coupling after operation contains similar structural components (UB, LB, TM, and M/A), which were found in the original coupling (Fig. 2 a–f). At the same time, during the transition to the area where the destruction occurred according to the SSC mechanism, significant changes in the microstructure are identified (Fig. 2 c–f).

In particular, in the area very close to a fracture, the microstructure is characterized by the absence of visible needle-like cementite particles in the plates (laths) (Fig. 2 c).

The absence of cementite particles both inside the plates and between them indicates the formation of a purely martensitic structure with a body-centered tetragonal (BCT) lattice [20]. The external applied load in the fracture zone leads both to the rotation of the plate-like structure in the direction of tensile forces and the formation of deformation bands (Fig. 2 d) and to the appearance of cracks on the non-metallic inclusions (Fig. 2 d, upper right corner, Fig. 2 e, upper left corner). Fig. 2 e, 2 f show a general view of the path of the secondary crack propagation as a result of SSC. It is obvious that at the initial stages, the crack propagates according to the transcrystalline type (up to 60 μm), and then it has an intercrystalline type (Fig. 2 e, 2 f). In this case, it is seen that, when stopped, a crack can be initiated at the boundary of the plates (Fig. 2 f). The analysis of SEM images showed that in all the studied areas, the PS coupling contamination with non-metallic inclusions did not exceed 5 points (SH method).

Fig. 2. Microstructure SEM images:
a – general view of the microstructure away from the fracture area; *b* – upper bainite plates;
c – general view of the microstructure in the fracture area; *d* – deformation bands;
e – the appearance of cracks in the fracture area; *f* – crack development on bainitic blocks.
 UB – upper bainite; LB – lower bainite

The analysis of the microstructure identified the presence of a structural gradient (UB, LB, TM, M/A, and martensite) in the PS coupling material. In particular, in the area close to the fracture, many martensite plates were found, which, apparently, locally increase the microhardness to 35.5 HRC. Martensite plates in the fracture area are characterized by the absence of cementite particles, the lath width in the range of $0.6\text{--}3.5 \mu\text{m}$, and the length of a few tens of μm . At the same time, areas with a high content of martensite/austenite component of irregular shape were found as well in this area. Numerous secondary microcracks are observed in the fracture area, since the martensitic structure is less SSC-resistant and requires additional tempering [21].

stages. At the first stage, it propagates along a rather straight trajectory. It is obvious that the crack thickness, which is approximately equal to 7.5 μm at the crack tip, remains virtually unchanged up to large depths (more than 60 μm) (Fig. 2 e). This fact indicates that up to the depths of 60 μm , corrosion processes are actively realized with the formation of iron oxides/sulfides. Further, the crack has a more tortuous propagation pattern containing a greater number of deflections (Fig. 2 e, 2 f). At the same time, at the initial stage, the type of crack propagation is transcrystalline (Fig. 2 e). Changes in the microstructure caused by the action of tensile stresses, and the formation of deformation bands shown in Fig. 2 d also led to this type of crack propagation. In this case, the deformation bands were formed as a result of the bainitic structure rotation in the direction of the action of tensile forces perpendicular to the fracture propagation line (Fig. 2 d, 2 e). The front of deformation bands reaches great depths and sometimes amounts to several hundred microns. As a result, in such areas, cracks easily propagate parallel to the dislocation slip lines, since there are no obstacles in their path. However, if a crack encounters in its path the transversely located bainite blocks, then it starts to slow down on them, as shown in Fig. 2 f. At the same time, the action of high applied tensile stresses sometimes leads to the initiation of secondary cracks in the areas close to the zone where the primary crack stops. Such areas are the MnS inclusions, spherical voids, PAGBs, and a favorable crystallographic texture between the plates (Fig. 2 e, 2 f, 3 a). Thus, more tortuous lines of crack propagation indicate the formation of bainite blocks with different crystallographic textures in these areas and demonstrate the best crack blocking action. In this case, the straight path of crack development implies the accelerated crack propagation in this area (Fig. 2 e). These facts are analyzed in detail by the EBSD method.

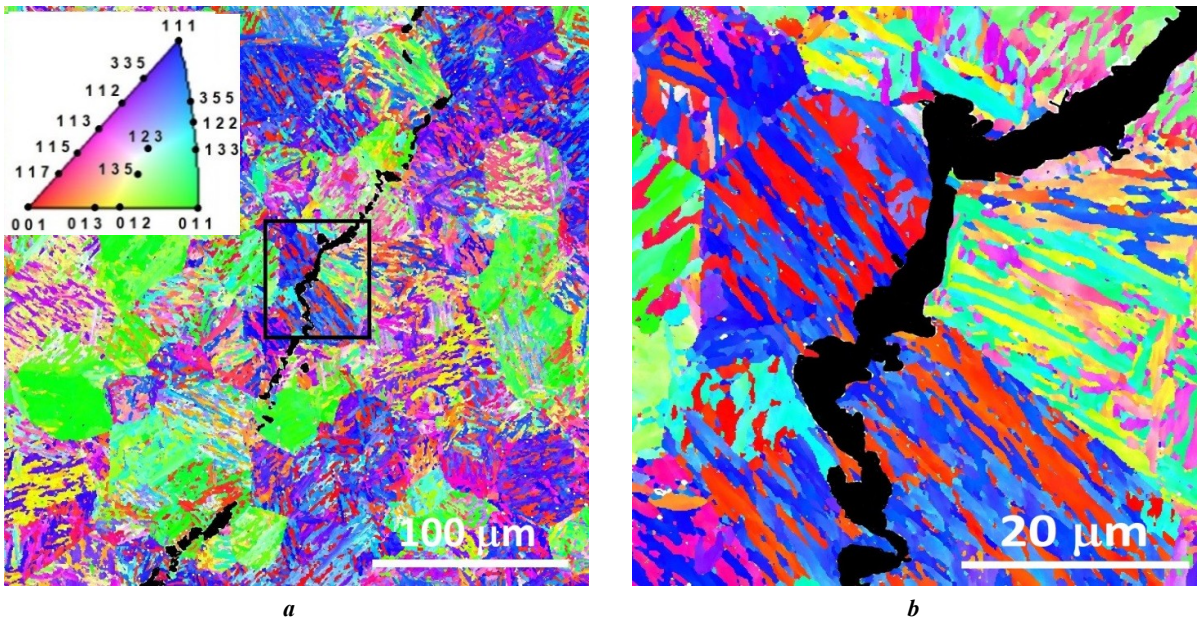
To analyze the nature of microcrack propagation, the authors studied the local crystallographic microtexture, i. e., the predominant grain orientations, as shown in Fig. 3 a. The analysis of the distribution map of grain orientations was carried out in the plane of the sample cross section. For ease of analysis, individual orientations of each block and plates are shown in different colors (Fig. 3 a, 3 b).

Fig. 3. EBSD images of the microstructure: **a** – general view; **b** – precision area
Рис. 3. ДОРЭ-изображения микроструктуры: **a** – общий вид; **b** – прецизионный участок

The EBSD analysis results clearly showed that the crack propagation nature has the straight-line sections, interruptions, and deflections (Fig. 3 a, 3 b). In particular, the transcrystalline type of crack propagation is typical for sections containing plates with $\{101\}$ $\langle 0\bar{1}0 \rangle$, $\{100\}$ $\langle 001 \rangle$, and $\{111\}$ $\langle \bar{1}00 \rangle$ orientations (Fig. 3 a). In this case, the intercrystalline type of crack propagation was identified for the bainite blocks belonging to the $\{122\}$ $\langle 2\bar{1}0 \rangle$, $\{111\}$ $\langle \bar{1}00 \rangle$, $\{012\}$ $\langle \bar{1}\bar{1}0 \rangle$, and $\{100\}$ $\langle 001 \rangle$ orientations. CSL

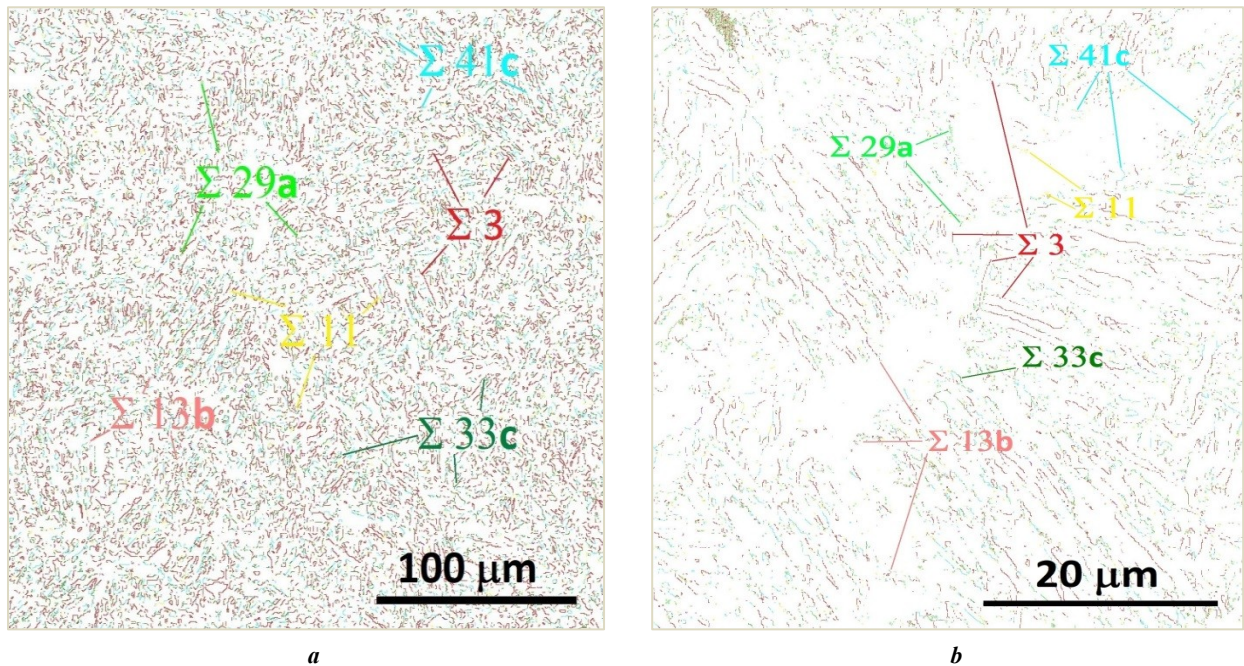
Besides, Table 2 shows schematically the orientations of individual plates with respect to the ND–TD plane and their volume fractions belonging to one or another texture component. To identify the influence of the texture formation processes on the nature of crack propagation, local EBSD studies were carried out (Fig. 3 b). In this case, the authors paid special attention to the identification of high-angle disorientations related to CSL grain boundaries formed both in the original coupling and in the coupling after operation (Fig. 4 a, 4 b). The distributions of CSL grain boundaries corresponding to the original and destroyed coupling (crack area) are shown in Fig. 4 a, 4 b, and their volume fractions are summarized in Table 3.

Fig. 4. EBSD images of the microstructure:
a – map of distribution of special grain boundaries in the coupling (pipe) without operation;
b – map of distribution of special grain boundaries in the crack area

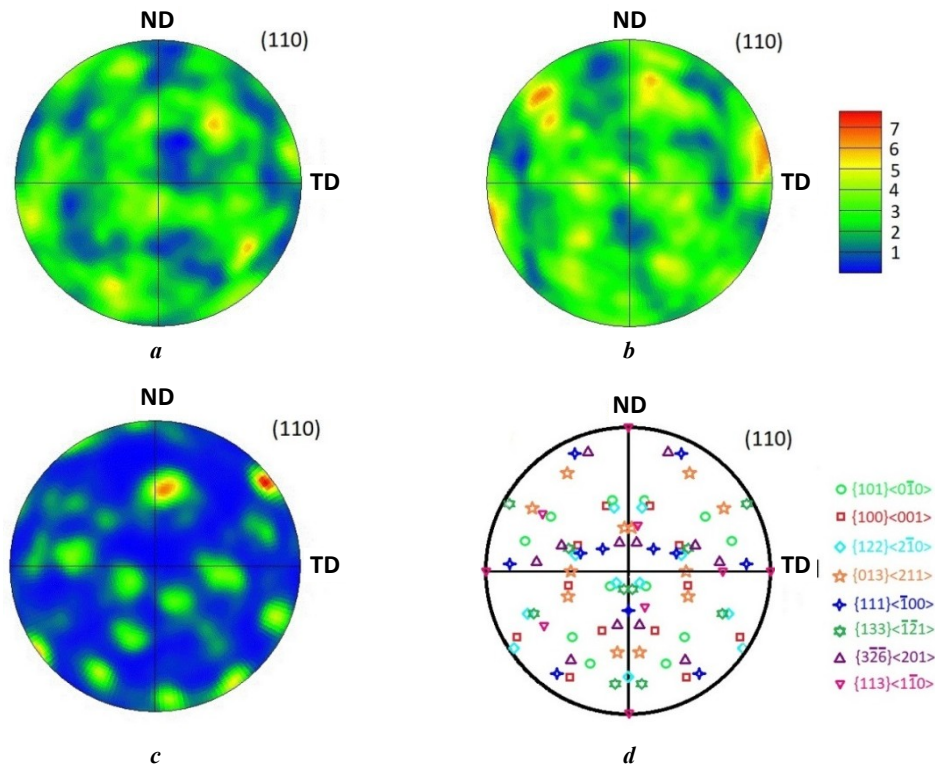
(Fig. 5, Table 2). Since the microtexture analysis covers the study of the crack development nature, Fig. 5 d and Table 2 show only the positions of the main grain orientations. The analysis showed that in the PS coupling after operation (away from the crack), the general appearance of the (110) PF remains. However, the ratio of the preferred grain orientations changes. This is evidenced by the redistribution of texture maxima on the (110) PF, where the $\{102\} \langle 2\bar{1}1 \rangle$, $\{230\} \langle 323 \rangle$, $\{122\} \langle 2\bar{2}1 \rangle$, $\{110\} \langle 1\bar{1}1 \rangle$ and $\{111\} \langle \bar{1}00 \rangle$, and $\{111\} \langle \bar{1}00 \rangle$ orientations are suppressed, while the $\{101\} \langle 0\bar{1}0 \rangle$, $\{100\} \langle 001 \rangle$, $\{013\} \langle 211 \rangle$, $\{122\} \langle 2\bar{1}0 \rangle$, and $\{133\} \langle \bar{1}\bar{2}1 \rangle$ texture components are enhanced (Fig. 5 b, Table 2). This fact is ex-

plained by the fact that during operation, the structure elements rotate as a result of the action of the applied external loads. Moreover, additional orientations (textural maxima) appear on the (110) PF and the pole density of some orientations sharply increases (Fig. 5 b). In particular, as a result of SSC, the weight fractions of the $\{001\} \langle 110 \rangle$, $\{100\} \langle 001 \rangle$, $\{112\} \langle 111 \rangle$, and $\{133\} \langle \bar{1}\bar{2}1 \rangle$ texture components increase (Fig. 5 b).

The precision microtexture analysis showed that the nature of the location of texture maxima on the (110) PF in the crack area changes significantly (Fig. 5 c). In this case, an increase in the pole density of individual orientations is observed (Fig. 5 c). In particular, in the zone

Fig. 5. Direct pole figures (110):
a – PS coupling before operation; *b* – after operation away from the crack;
c – in the crack area; *d* – the positions of the determined orientations on a pole figure

of crack development, there is a sharp increase in the $\{101\} \langle 0\bar{1}0 \rangle$, $\{100\} \langle 001 \rangle$, $\{122\} \langle 2\bar{1}0 \rangle$, and $\{133\} \langle \bar{1}\bar{2}1 \rangle$ grain orientations, uncharacteristic for the initial PS coupling. In general, the changes in the (110) PF, on the one hand, are associated with the formation of an unfavorable crystallographic texture, and, on the other hand, with the active processes of grinding bainite blocks and subsequent reorientation of the plates as a result of shear deformations.
