The effect of strain rate on mechanical properties and fracture mode of the AZ31 alloy and commercially pure magnesium pre-exposed in a corrosive medium

Togliatti State University, Togliatti (Russia)

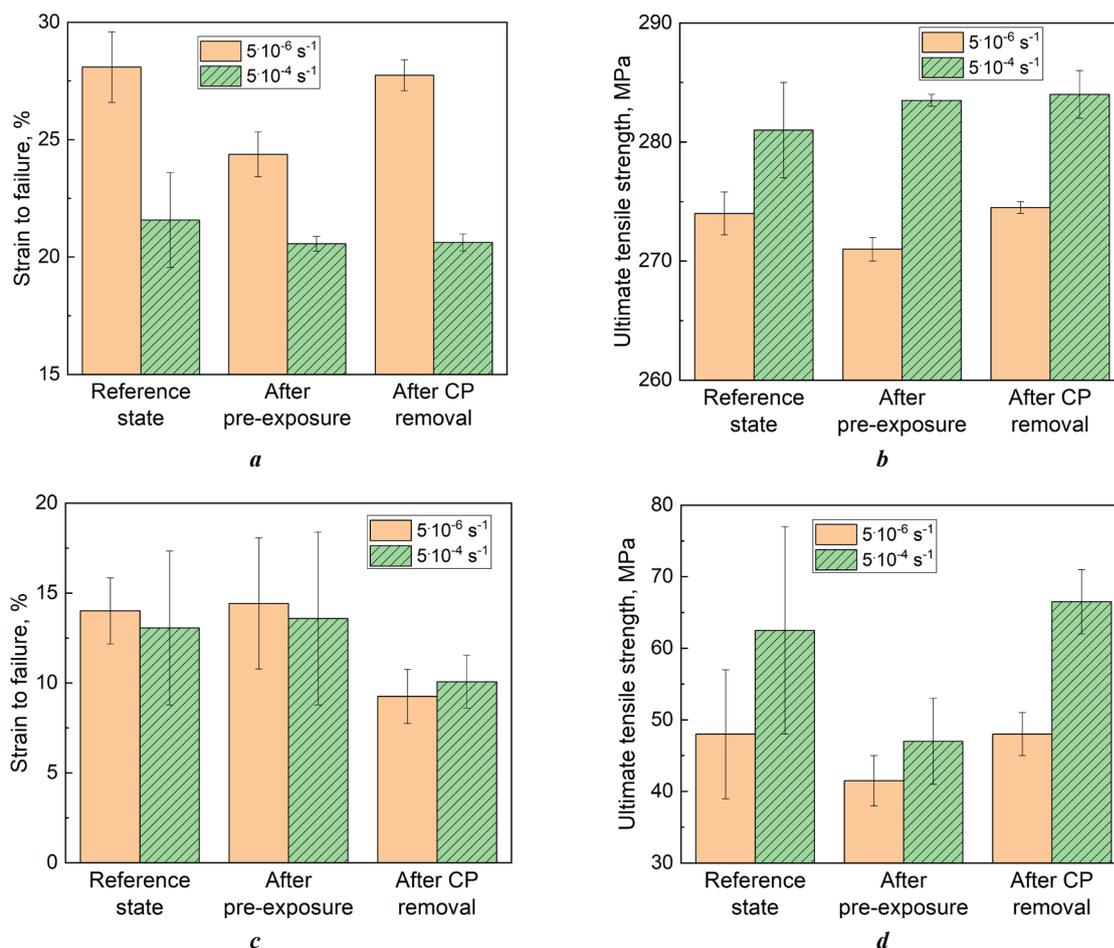
Fig. 1. The effect of strain rate on elongation to failure (a, c) and ultimate tensile strength (b, d) of the AZ31 alloy specimens (a, b) and technically pure magnesium specimens (c, d) in the reference state, after the pre-exposure to a corrosive medium, and after the pre-exposure to a corrosive medium followed by the removal of corrosion products

As a result of the experiments, it was found that an increase in the strain rate of samples of the AZ31 alloy in the reference state leads to a decrease in their ductility and an increase in strength (Fig. 1 a, 1 b, 2 a). The tests at a low strain rate showed that preliminary holding of samples of this alloy in a corrosive environment leads to a decrease both in its strength and ductility (Fig. 1 a, 1 b, 2 a). However, at a high strain rate, there is no decrease in mechanical properties after corrosion exposure. Moreover, the complete restoration of the alloy mechanical properties occurs if, after soaking in a corrosive environment, corrosion products are removed from the surface of the samples. This effect is observed both at low and high strain rates.

The ductility of the reference pure magnesium samples slightly depends on the strain rate, and the increase in the strength with increasing strain rate is much weaker than that of the AZ31 alloy (Fig. 1 c, 1 d, 2 b). Preliminary exposure to a corrosive environment does not have a significant effect on the pure magnesium ductility, but leads to a slight decrease in its strength, which slightly increases with an increase in the strain rate. Interestingly, the ductility of pure magnesium specimens with the removed corrosion products is significantly lower than that of specimens in the reference state and specimens kept in a corrosive environment, from the surface of which corrosion products were not removed.

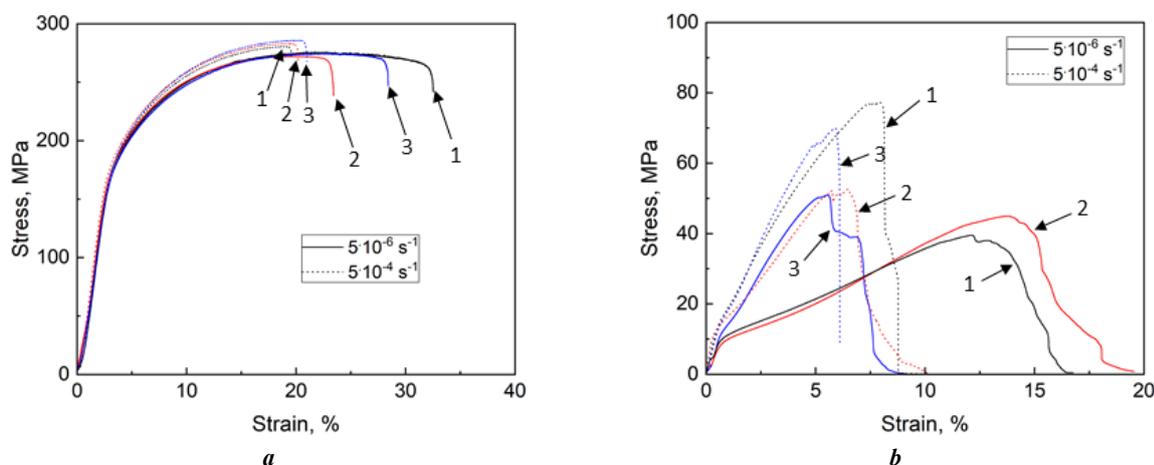
Fig. 2. The effect of strain rate on the stress-strain diagrams of the AZ31 alloy specimens (a) and technically pure magnesium specimens (b) in different states: 1 – reference state; 2 – after the pre-exposure to a corrosive medium; 3 – after the pre-exposure to a corrosive medium and the removal of corrosion products

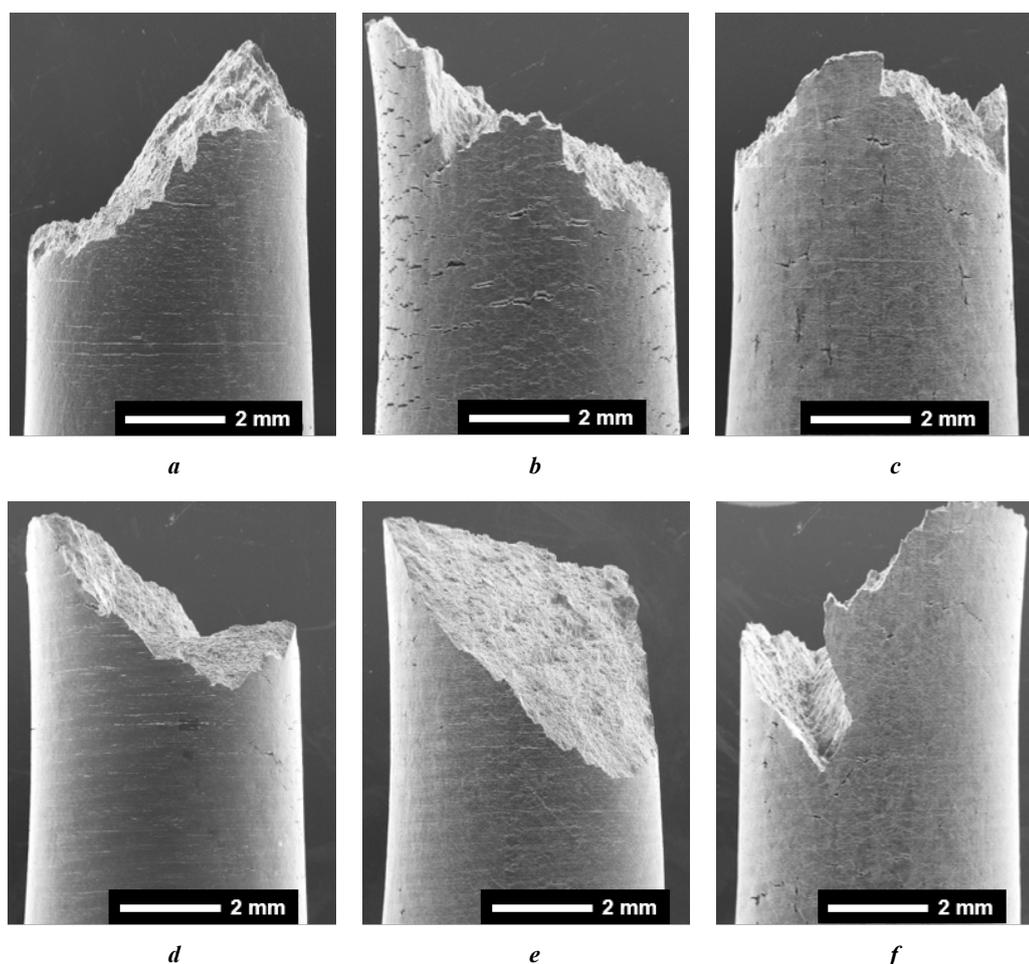
Fig. 3. The appearance of the side surface of the AZ31 alloy specimens tensile-tested in air: **a, d** – in the reference state; **b, e** – after the pre-exposure to a corrosive medium; **c, f** – after the pre-exposure to a corrosive medium and the removal of corrosion products: **a–c** – at a low ($5 \cdot 10^{-6} \text{ s}^{-1}$) strain rate; **d–f** – at a high ($5 \cdot 10^{-4} \text{ s}^{-1}$) strain rate. Images are obtained by SEM

On the side surface of the AZ31 alloy specimens (Fig. 3) tested for tension in the initial state, a large number of small ductile cracks oriented across the tension axis are

observed (Fig. 3 a, 3 d). These cracks appear along the grooves formed by the cutter on the metal surface during turning. On the surface of the samples that were subjected to soaking in a corrosive environment followed by a tensile test at a low strain rate, there are also many cracks, which, however, are much larger and more brittle compared to cracks on the reference samples (Fig. 3 b). After testing at a high strain rate, there are practically no such large cracks in specimens of a similar type (Fig. 3 e). Large cracks are present on the surface of samples from which the corrosion products were removed before testing, but their quantity is significantly less than that of samples that were tested after holding in the environment without removing the corrosion products (Fig. 3 c).

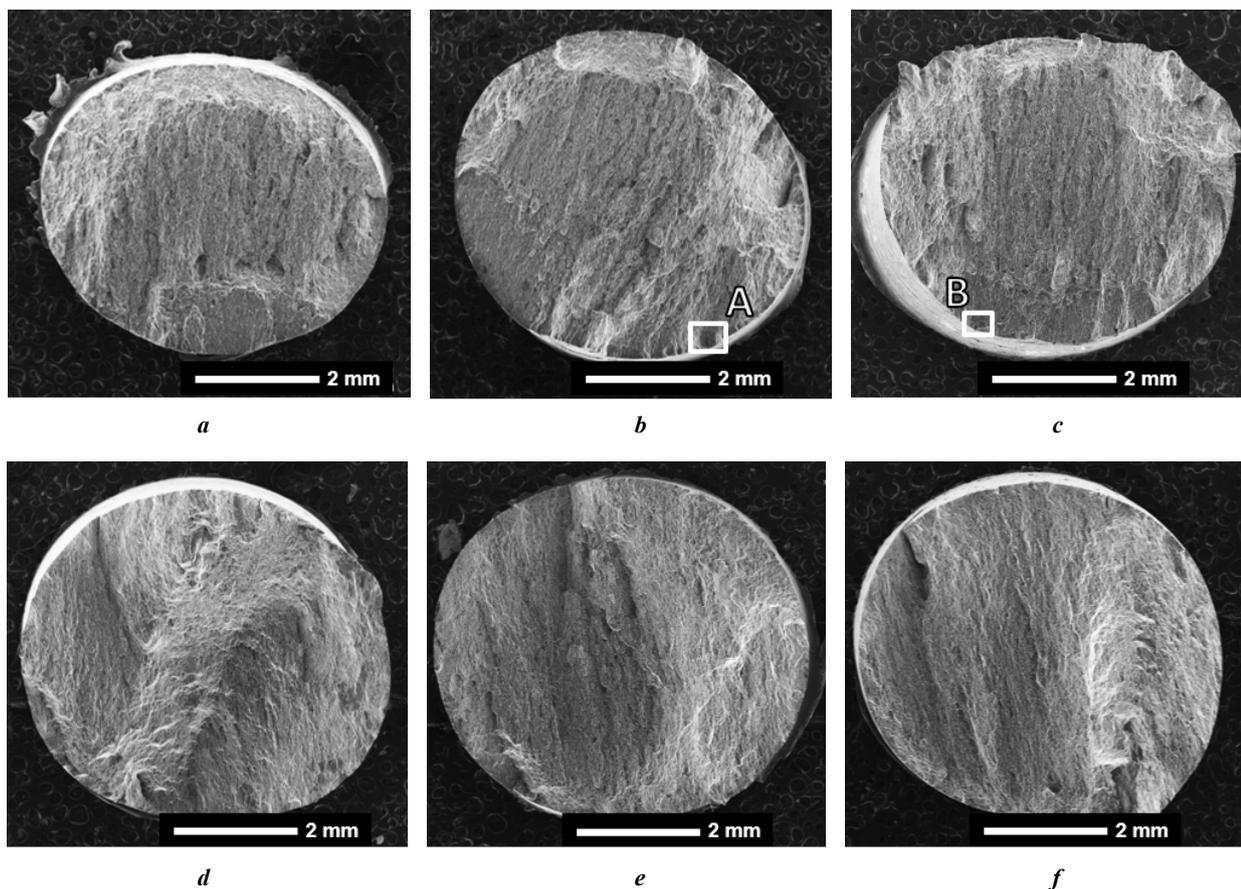
Fig. 4. The appearance of the fracture surface of the AZ31 alloy specimens tensile- tested in air: **a, d** – in the reference state; **b, e** – after the pre-exposure to a corrosive medium; **c, f** – after the pre-exposure to a corrosive medium and the removal of corrosion products: **a–c** – at a low ($5 \cdot 10^{-6} \text{ s}^{-1}$) strain rate; **d–f** – at a high ($5 \cdot 10^{-4} \text{ s}^{-1}$) strain rate.

Images are obtained by SEM. The blocked "A" and "B" areas are shown in Figure 5

The fractographic analysis (Fig. 4) showed that the fractures of the AZ31 alloy reference samples are fully-ductile, regardless of the strain rate (Fig. 4 a, 4 d). On the fracture surface of specimens tested at a low strain rate and after pre-exposure to a corrosive medium, together with the dominant ductile component, there are multiple brittle fracture areas, which are always located in the peripheral part of the fracture and directly adjacent to the side surface of the specimen (Fig. 4 b). One of these brittle areas is blocked with a frame ("A" area in Fig. 4 b) and is shown at higher magnification in Fig. 5 a.

On the fracture surface of specimens with the removed corrosion products tested at a low strain rate, there are also a small amount of such brittle fracture areas (Fig. 4 c and 5 b); however, their quantity is significantly less than in specimens from which the corrosion products were not removed. The fractures of all specimens pre-exposed to a corrosive environment and tested at a high strain rate are fully-ductile and do not contain brittle fracture areas, regardless of whether the corrosion products were removed from them or not (Fig. 4 d–f).

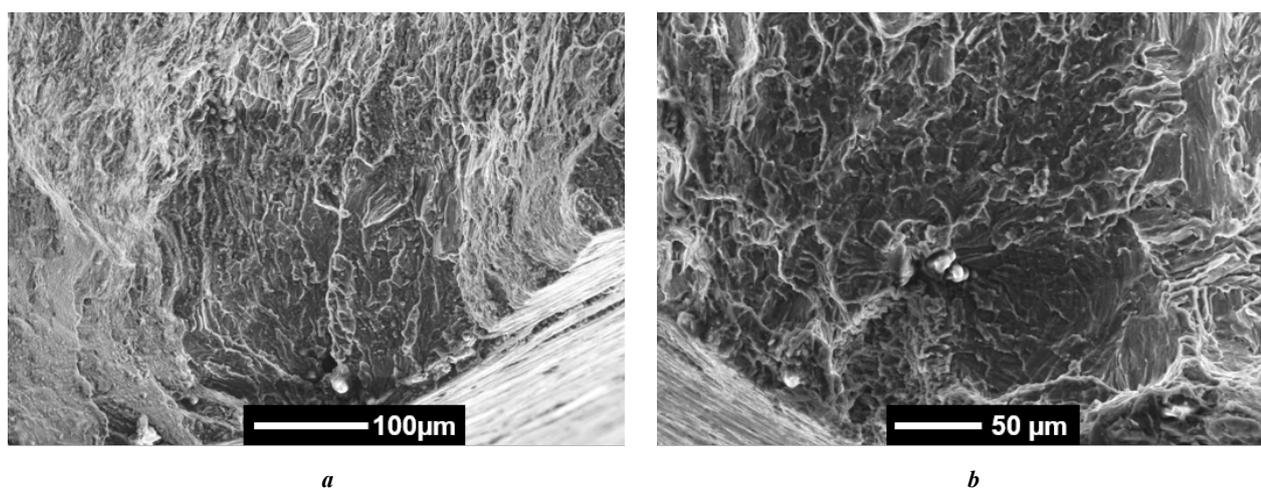
Fig. 5. The magnified fracture surface areas blocked in the frames in fig. 4 b and 4 c, respectively: **a** – "A" area; **b** – "B" area, containing the regions of brittle fracture in the peripheral part of the fracture surfaces of the AZ31 alloy specimens tested at a low strain rate immediately after the pre-exposure to a corrosive medium (**a**) and after the removal of corrosion products (**b**). Images are obtained by SEM

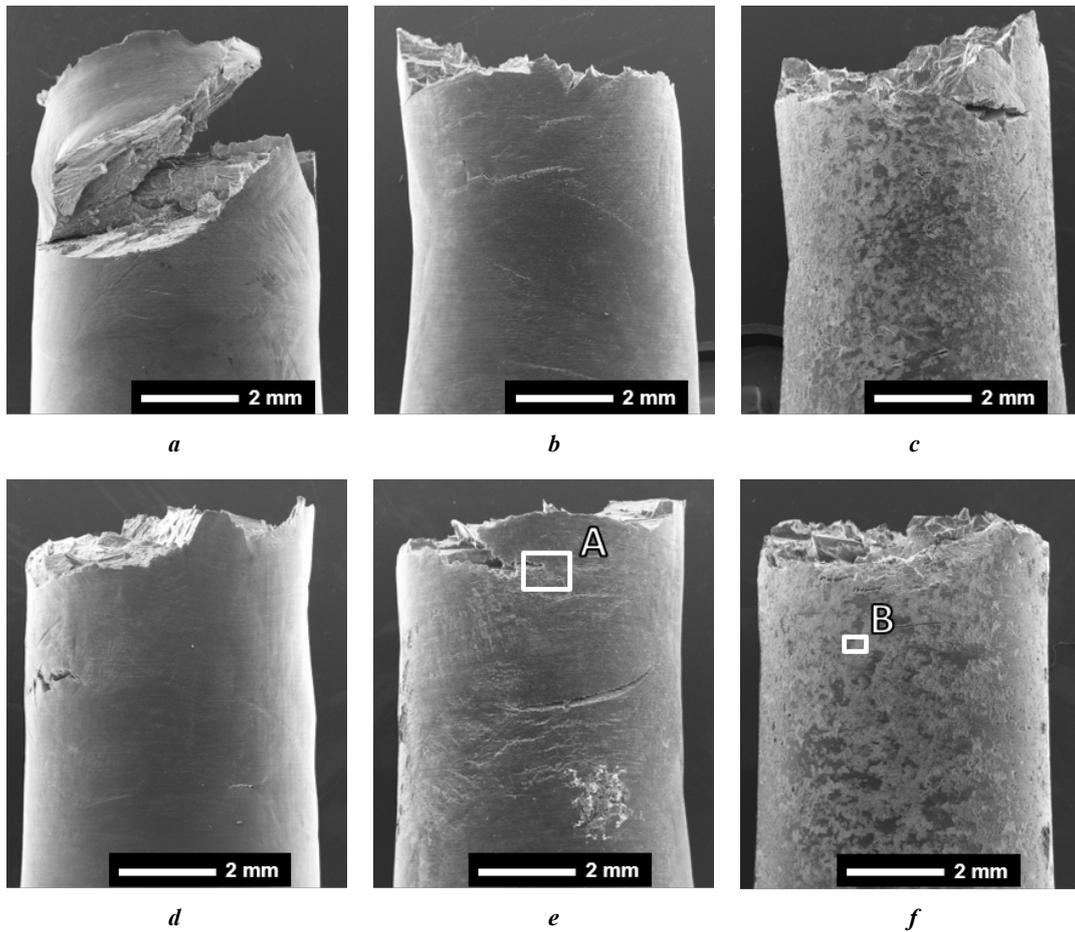
Fig. 6. The appearance of the side surface of the technically pure magnesium specimens tensile-tested in air: **a, d** – in the reference state; **b, e** – after the pre-exposure to a corrosive medium; **c, f** – after the pre-exposure to a corrosive medium and the removal of corrosion products: **a–c** – at a low ($5 \cdot 10^{-6} \text{ s}^{-1}$) strain rate; **d–f** – at a high ($5 \cdot 10^{-4} \text{ s}^{-1}$) strain rate.

Images are obtained by SEM. The blocked "A" and "B" areas are shown in Figure 7

On the side surface of pure magnesium specimens tested in the reference state and after soaking in a corrosive environment, including the subsequent removal of corrosion products, there are large cracks and numerous slip bands (Fig. 6). Moreover, a network of small cracks is also observed on the surface of specimens pre-exposed to a corrosive environment (Fig. 6 e and 7 a). Interestingly, there is a large quantity of corrosion pits on the surface of samples with the removed corrosion products (Fig. 6 c, 6 f, and 7 b), which are not observed on the surface of samples tested immediately after soaking in a corrosive environment (without the removal of corrosion products). No critical effect of the strain rate on the appearance of the side surface of pure magnesium specimens in the initial state and after soaking in a corrosive medium was found.

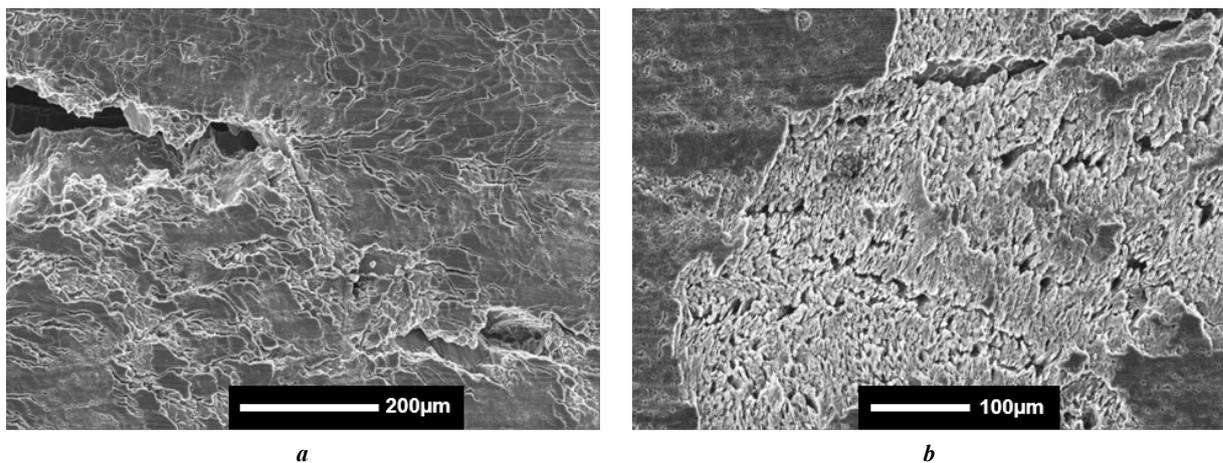
Fig. 7. The magnified side surface areas blocked in the frames in fig. 6 e and 6 f respectively: **a** – "A" area; **b** – "B" area, illustrating the brittle cracks net (**a**) and corrosion pits (**b**) on the surface of technically pure magnesium specimens tested at the low strain rate right after pre-exposure to corrosive medium – **a**; as well as after the removal of corrosion products – **b**. The images are obtained by SEM

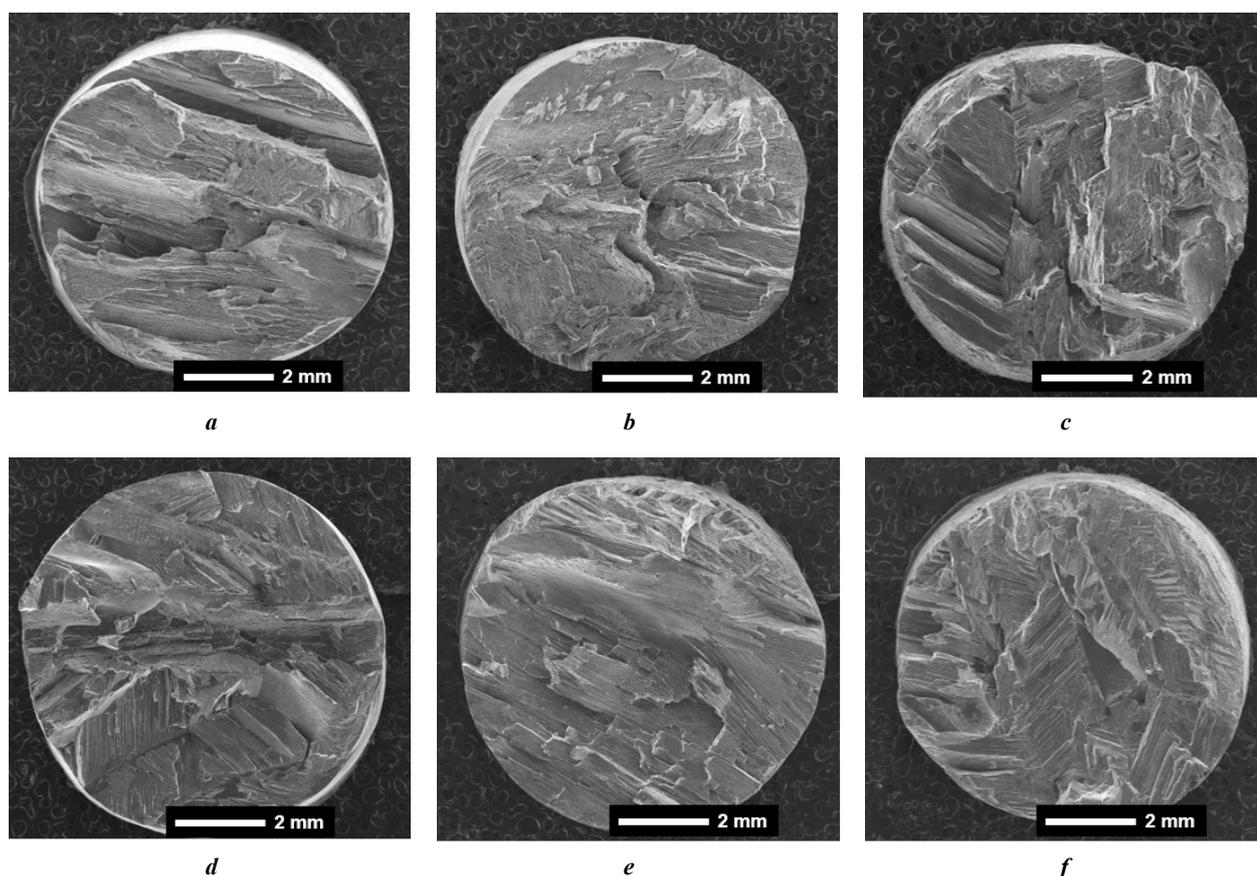
Fig. 8. The appearance of the fracture surface of the technically pure magnesium specimens tensile-tested in air: *a, d* – in the reference state; *b, e* – after the pre-exposure to a corrosive medium; *c, f* – after the pre-exposure to a corrosive medium and the removal of corrosion products: *a–c* – at a low ($5 \cdot 10^{-6} \text{ s}^{-1}$) strain rate; *d–f* – at a high ($5 \cdot 10^{-4} \text{ s}^{-1}$) strain rate.

Images are obtained by SEM

The fracture surface of all pure magnesium samples has a similar structure, regardless of the strain rate and the type of samples (Fig. 8). In all cases, the fracture is represented mainly by the facets with a fluted relief. Smooth facets without clearly defined relief are occasionally found.
